# Anomalous behavior investigation of the sealing core at the Slezska Harta dam

František Glac

## Abstract

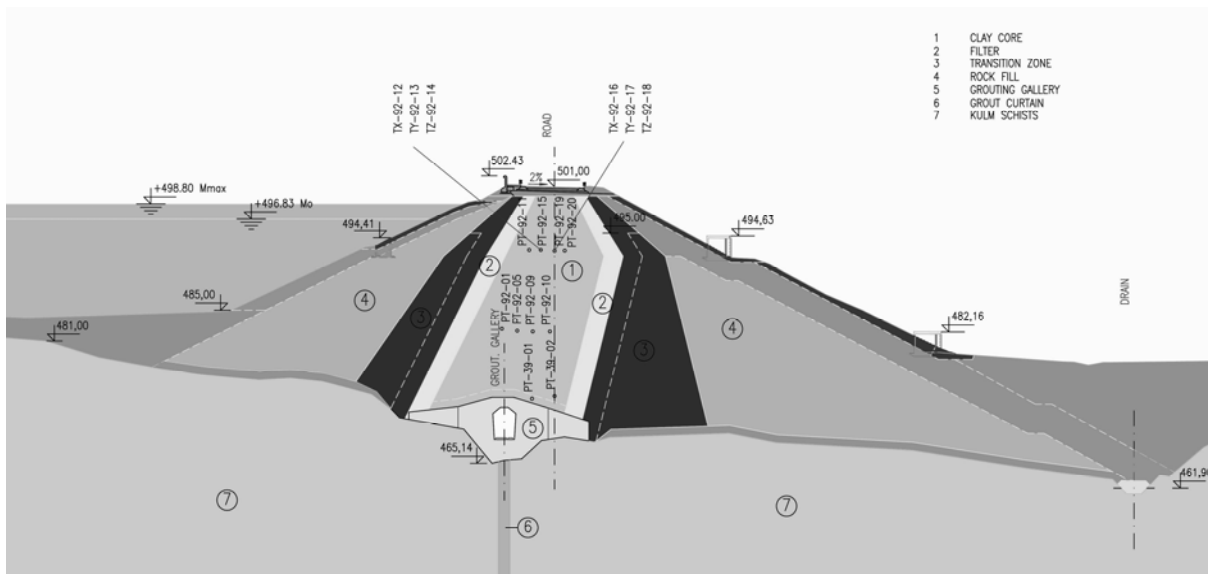
**Figure 1:** Instrumentation in right abutment

In the right abutment, there are gauges placed in two levels (**Figure 1**). Since June 2001, the change in level of pore and total pressures in the upper group of gages was observed. From that time, values of pressure immediately react to change of water level in reservoir. Level of

pressures indicated connection with water level in reservoir. The group of sensors consists of ten sensors which are divided into four groups. There are four sensors of pore pressure, each in one group and six sensors of total pressure. All of them had a similar reaction.

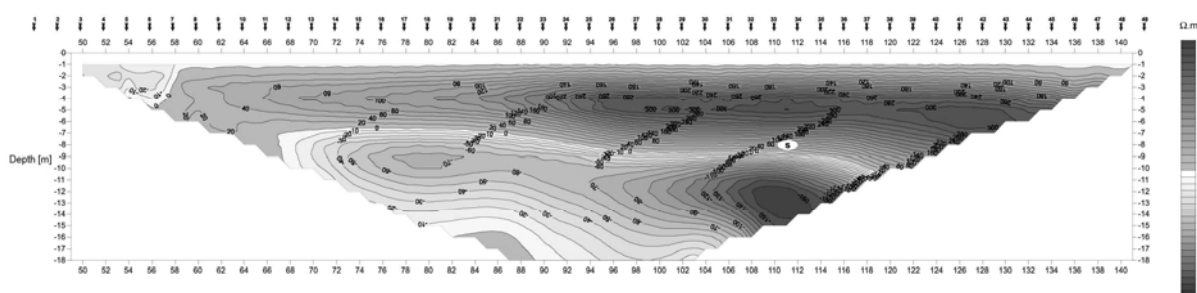
There were used two methods: multi-electrode cable for resistance measurement and ground penetrating radar (GPR). For the first one, holes were drilled with 2 m spacing across the roadway construction to the clay core and electrodes were placed there. Measurements were carried out in two areas; under the cut with sensors and the other one in the middle of the dam. It was measured twice with different level of water in reservoir. Result was the foundation of the location with increased resistance near the group of sensors (**Figure 2**) [2]. The cut is more than 8 m under the crest. The GPR measurement did not indicate any anomaly and it was evaluated as unsuitable.

**Figure 2:** Result of geophysics measurement

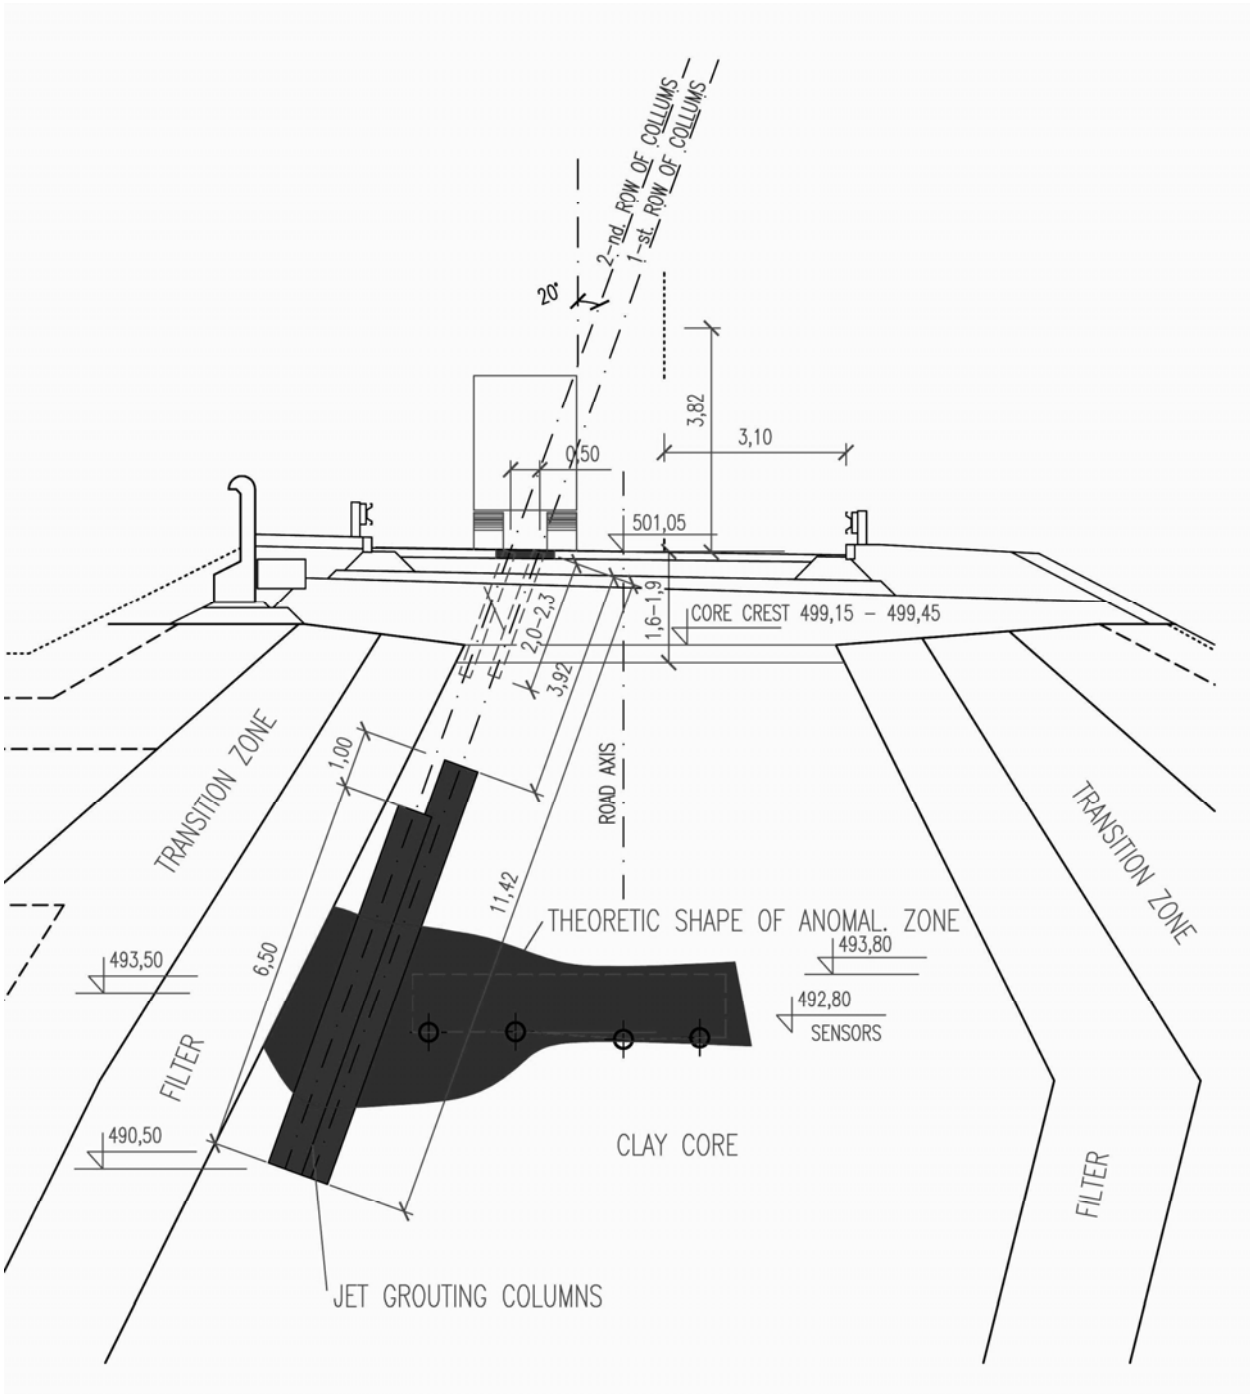
**Figure 3:** Repair scheme

For the limitation of defective site, dynamic penetration test was realized in nine places. Results confirmed that there is strictly bounded 1.5 m wide area with humid and porous clay and that this area is not going crosswise the clay core.

For repair of that site, technology which could create impermeable element in upstream part of clay core was searched. The material of that element has to have similar deformation properties like the origin undamaged clay core. Technology of jet grouting was used. There were created 41 columns consequently in two rows. The expected values of impermeability, solidity and deformational module were achieved. It was confirmed by two boreholes witch were carried out 90 days after grouting work. All installed sensors are still work. They could be used for control of seepage throw the new sealing.
